HIGH POTENTIAL INCIDENT ANNOUNCEMENT URGENT

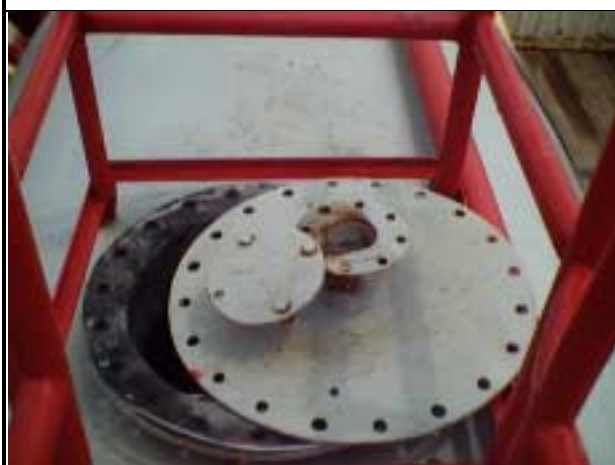
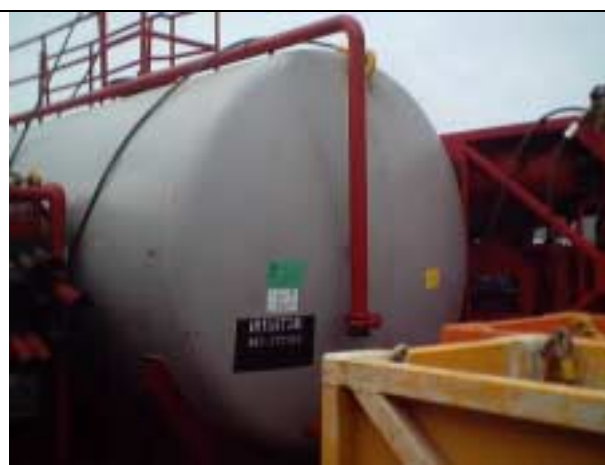
A 10,000 gallon tank was lifted from the drilling rig onto the Platform Supply Vessel for shipment back to shore. During the journey to the supply base, the vessel's deck crew noticed that the hatch lid had slipped from its normal position and subsequent investigation showed that it was completely unsecured. The lid weighs approximately 20 kg.

Potential Outcome	Fatality to single person If the lid had fallen and struck somebody while being lifted onto or off the PSV, it could have resulted in a fatality.
Likely Causes	Immediate causes - Failure to secure the hatch lid - Failure to inspect the lift prior to backloading
Actions Taken	- Hatch lid secured for remainder of journey to shore. - Backload checklist developed and implemented by tank supplier. - Reviewed with crews the importance of inspecting all lifts for loose objects. (Requirement is already in rigsite procedures and checklists) - Ordered hinged lids to replace bolted covers.
